Plick and Associates, Forensic Engineers

Forensic Engineering Newsletter

Volume III, Issue I

Why Underpinning is So Important

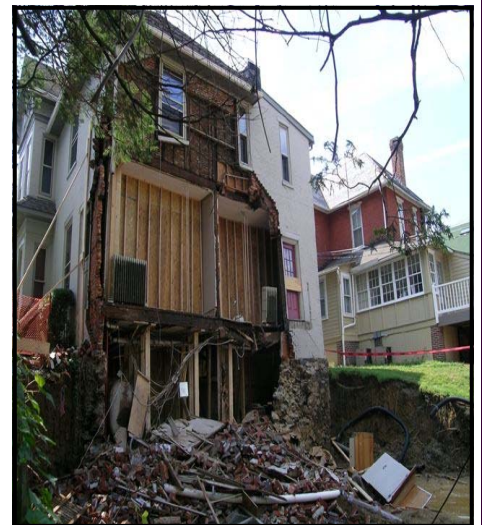
Such an excavation presents many challenges to be dealt with before the first bucketful of dirt is moved. First and foremost, a plan must be developed for the adjacent existing foundation to be underpinned to a depth equal to the depth of the foundation for the new construction. This requires the soil beneath the existing foundation be removed and replaced with a constructed element, such as a concrete wall. The soil beneath the entire length of an existing wall cannot be removed without the existing foundation collapsing. Therefore, underpinning is accomplished in sections, sometimes as little as two feet at a time, while the remainder of the foundation remains supported by soil or by previously constructed sections of underpinning. Failures often occur when a contractor does not underpin or elects to underpin a section of the existing foundation that is too long to support itself. The proper length of each section is a factor of the soil conditions and the strength and integrity of the existing foundation.

Another challenge is the risk there will be a collapse during the process of excavating down to the bearing elevation of the existing foundation, before the underpinning is initiated. The probability of this type of failure is high in older cities where the adjacent foundation wall may be 100 years or older. In the past, some foundations were constructed by digging a trench and filling it with rubble. This type of foundation has no inherent strength once the soil on one side is removed. Similar failures can occur in old stone masonry foundations where the mortar originally securing the individual stones has long since deteriorated.

“The City has recently experienced several building collapses attributed to builders digging basements and footings too close to existing buildings. In particular, many older buildings in Philadelphia are supported on rubble stone foundation walls with minimal or no spread footings below. When such walls are exposed or undermined they become unstable and are prone to sudden catastrophic failure. Building collapses have also been caused by property owners that attempt to increase the height of their basements by digging out the basement floor. Though the danger is most acute with rubble stone foundation walls, damage and failure can occur whenever structures are undermined, regardless of their age or condition. This Code Bulletin will set forth construction document requirements to aid in enforcing the code section that addresses this concern.”

The bulletin requires a registered professional engineer plan the underpinning process and engineer perform special inspections during the process. However, the continued frequency of recent building wall collapses suggests these requirements are not being implemented with adequate vigilance.

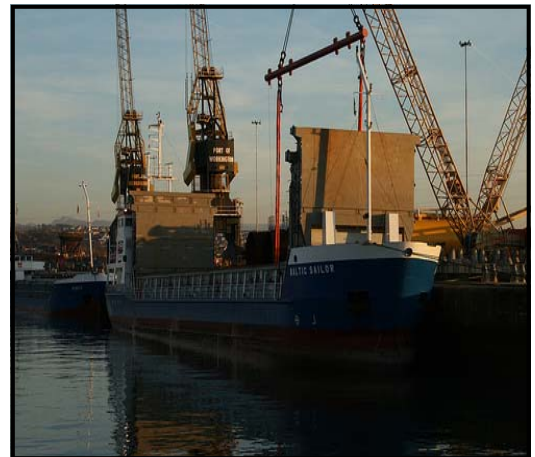
Finally, an occasion arose when the ship was in dock and unloading under similar conditions as the time of the accident, with sufficient time to allow for the investigation. The weather conditions were similar and illumination levels were taken with light meters. Most importantly, color photographs were taken with a 35mm camera without the use of a flash attachment. The photographs taken were in the environment of the existing lighting on the ship.

The suit was tried in the United States District Court for the Eastern District of Pennsylvania. The trial was a "bench" trial, tried only in the presence of a judge. The defense received a favorable verdict. Whereas, the case was decided by many factors, an important and deciding contribution was the photographs taken of the location and under similar conditions of the accident. The old adage prevailed: "A picture is worth a thousand words."
